Queensland BHP Steel: diagnosis of a fan bearing problem

by **Peter Cleary**
*Process Efficiency Engineer,
Queensland BHP Steel
Acacia Ridge, Queensland, Australia*
and **David Eden**
*Managing Director,
Rotor Dynamics Pty. Ltd.
Oatley, New South Wales, Australia*

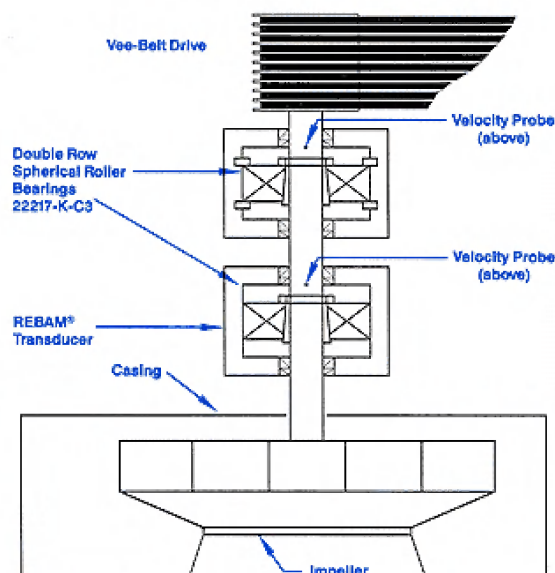
The bearings have demonstrated poor reliability since original commissioning, with run lives varying from a few days to about nine months. The fan's operating speed is generally considered marginal for grease lubrication, and operating temperatures tend to be high. To monitor these temperatures, thermocouples were placed in contact with the bearing outer rings some years ago.

Figure 1
Queensland BHP Steel's overhung impeller-type combustion air fan.

Practically all bearings have displayed some degree of fretting damage to the outside of the outer ring. At times, damage was only minor and was generally considered to be of secondary importance to the high temperatures.

The high temperatures observed during resonance are attributed to high amplitude and high frequency impact and fretting (at 2X running speed) between the bearing outer rings and the plunger blocks.
